MEMORANDUM

SUBJECT: Hunters Point Building 364 Removal Action Findings

Building 364 Removal Actions:

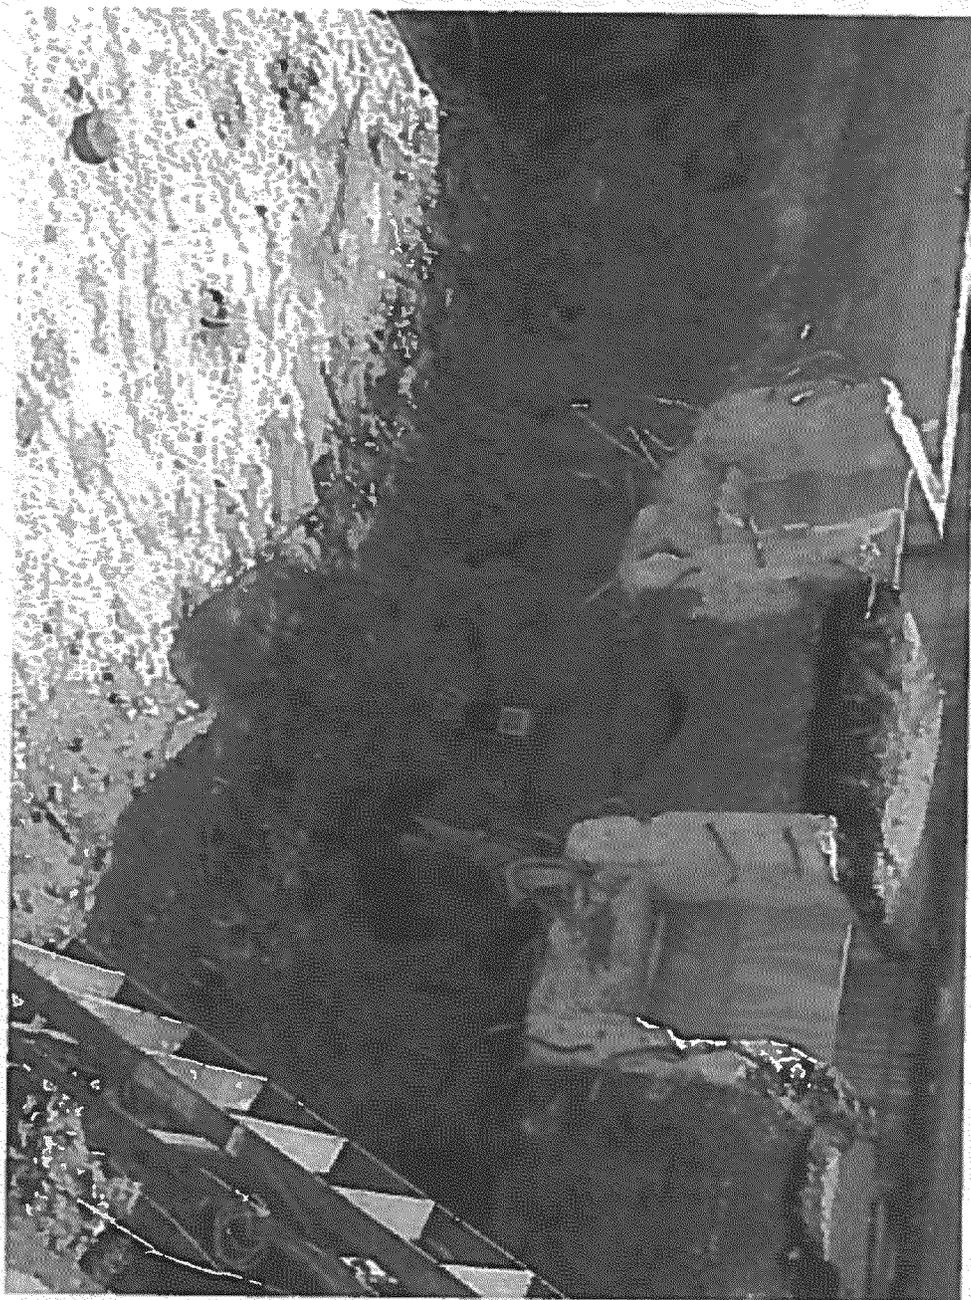
Sump Removal Pit Wall Spectrum Analysis

While this area exhibited the highest gross gamma reading in the pit, the gamma spectrum shows that no gamma emitting radioactive contaminant is present. The elevated background was from the configuration of the wall's undercutting and nearby concrete structures which changed the counting geometry and thus increased the probe's detection efficiency. This translates into a slightly higher peak in the Compton scatter region, from zero to about 400 kilo-electron-volts (keV), of the spectrum. With this one exception, the wall's spectrum compares well to a background spectrum taken on unimpacted asphalt near Building 364. No Radium-226 (Ra226), Cs-137, or other radionuclide contaminants of concern are present in the spectrum.

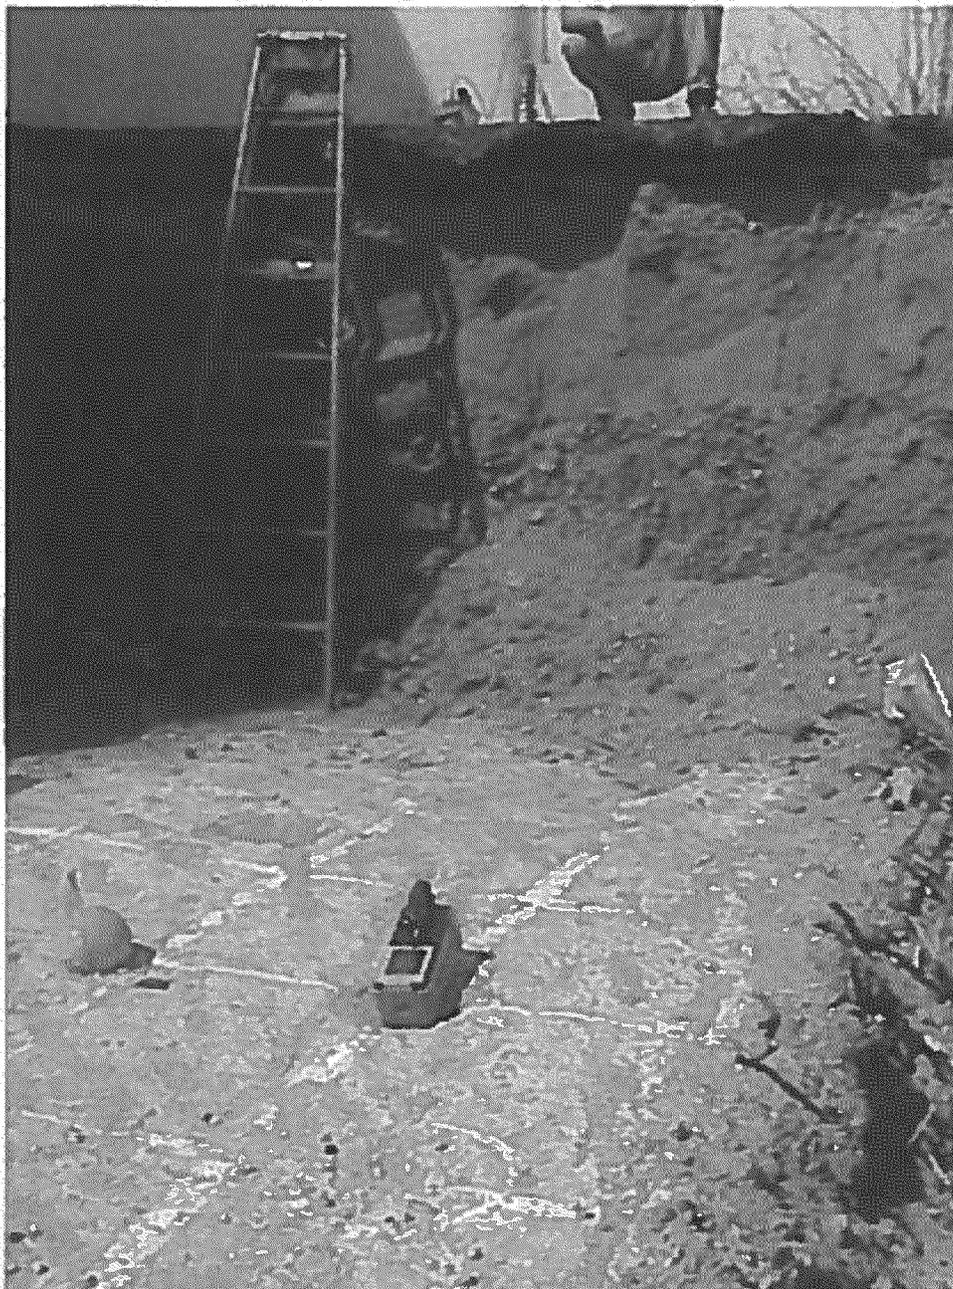
Sump Removal Pit Floor Spectrum Analysis

One small indentation in the concrete floor had slightly higher gamma counts. The

indentation was made by workers while removing a small area of fixed contamination on the concrete floor. The spectrum of this area revealed no evidence of any residual radioactive contamination.

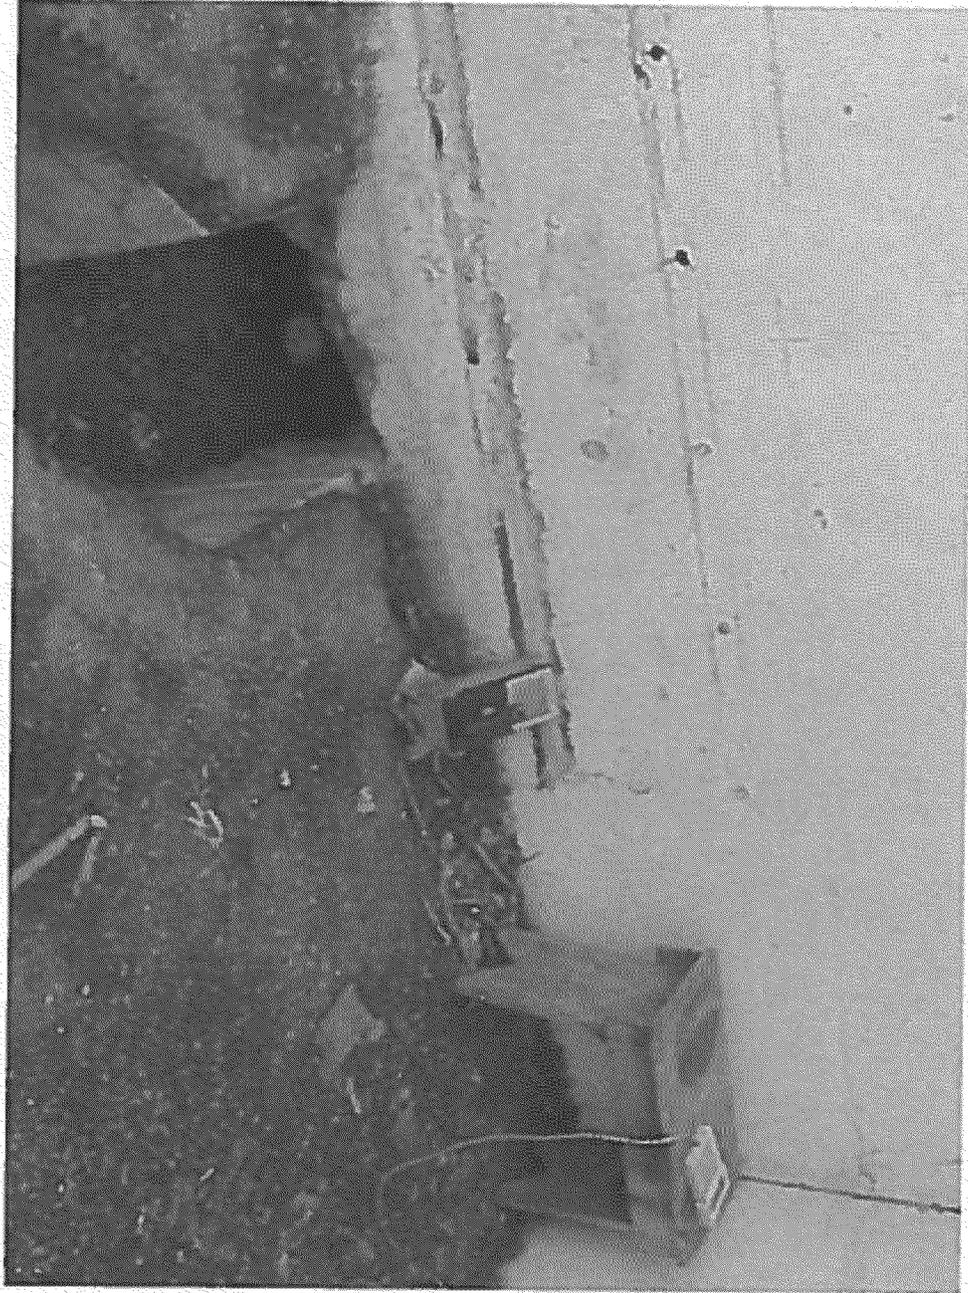
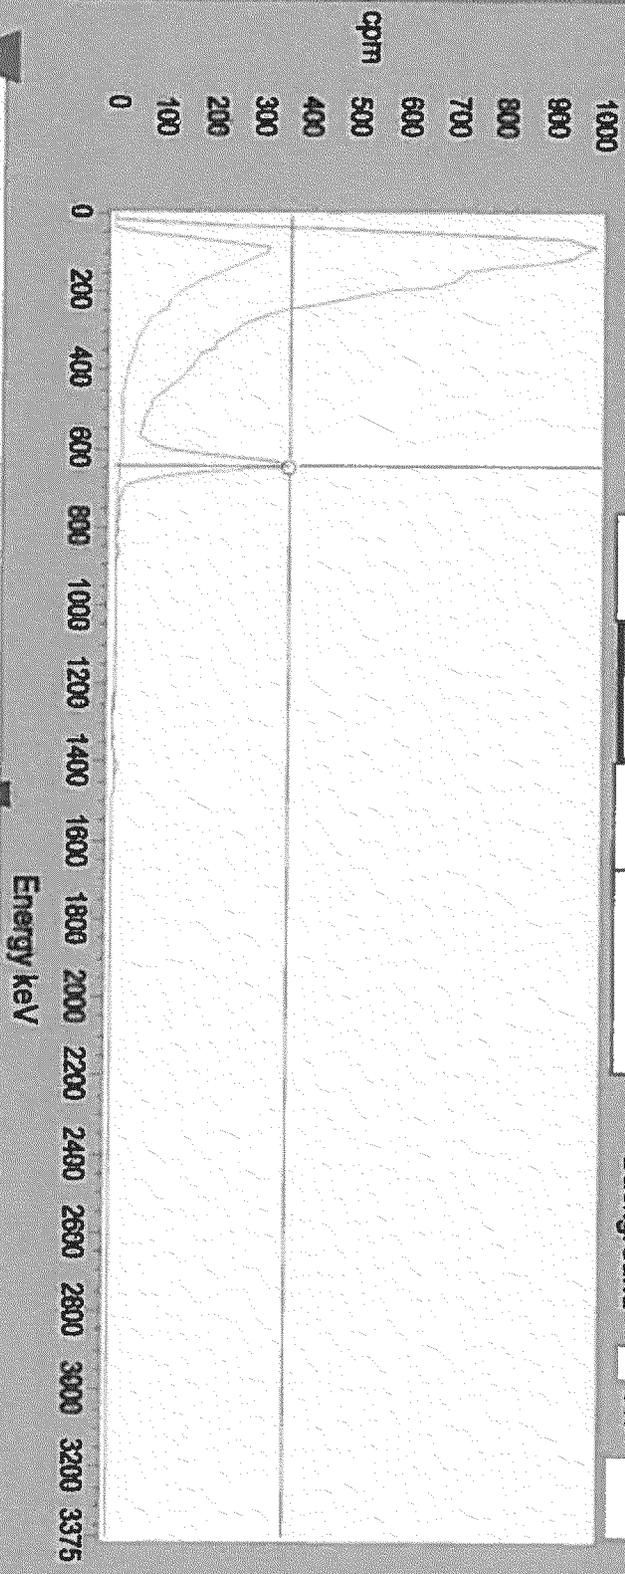
B364 Vent Wall Spectrum Analysis

A spectral analysis of the exterior wall of Building 364 exhibited conclusive evidence that considerable Cs137 contamination is present. The Cs137 is localized in a seam between the original wall and a concrete patch that was applied to an old ventilator duct that passed through the exterior wall. This area requires remediation.

HPNS Building 364 Exterior Wall (blue) vs Asphalt Background (green)

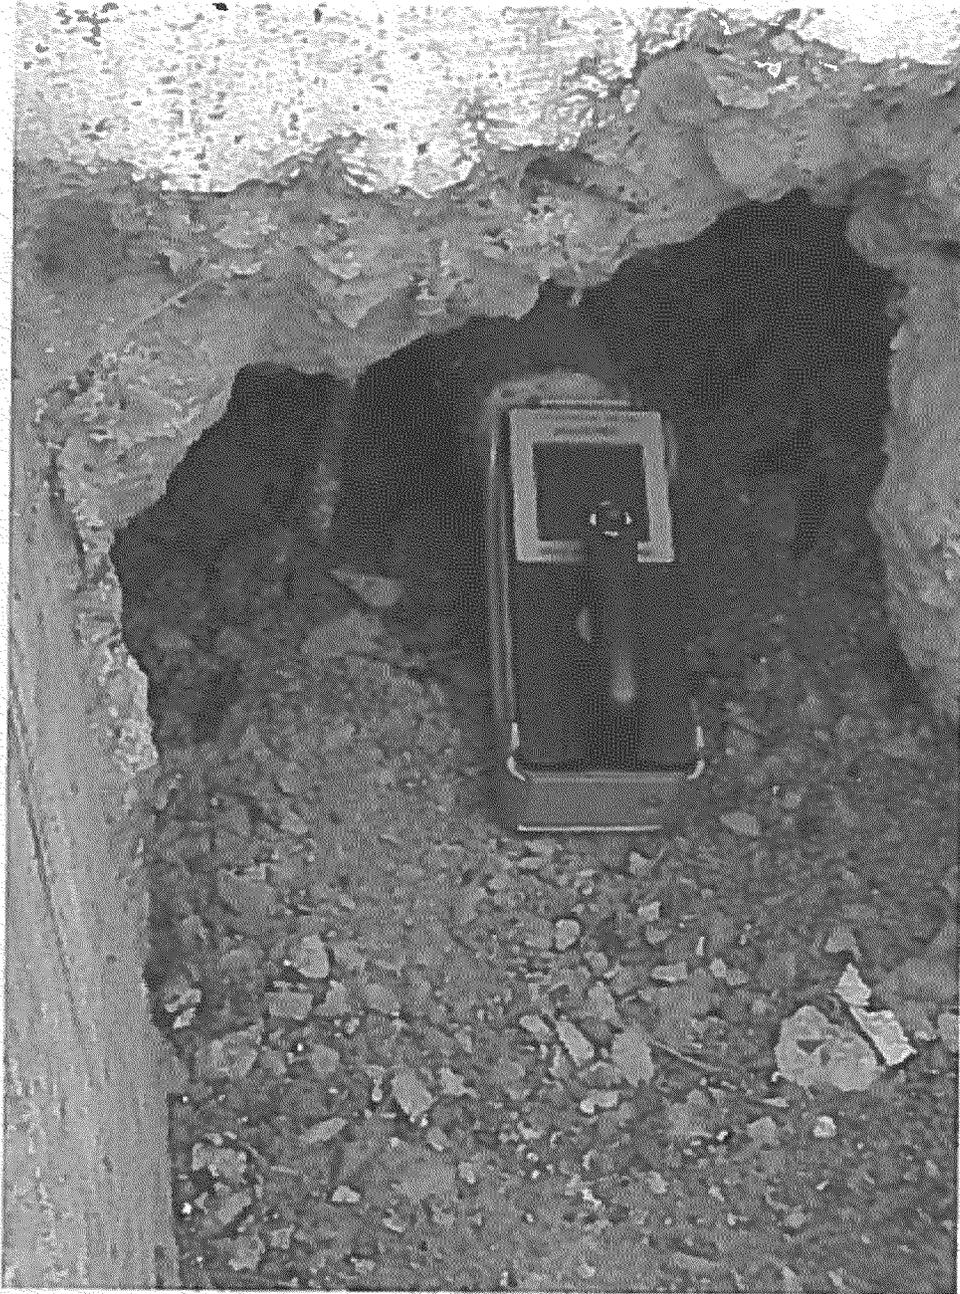
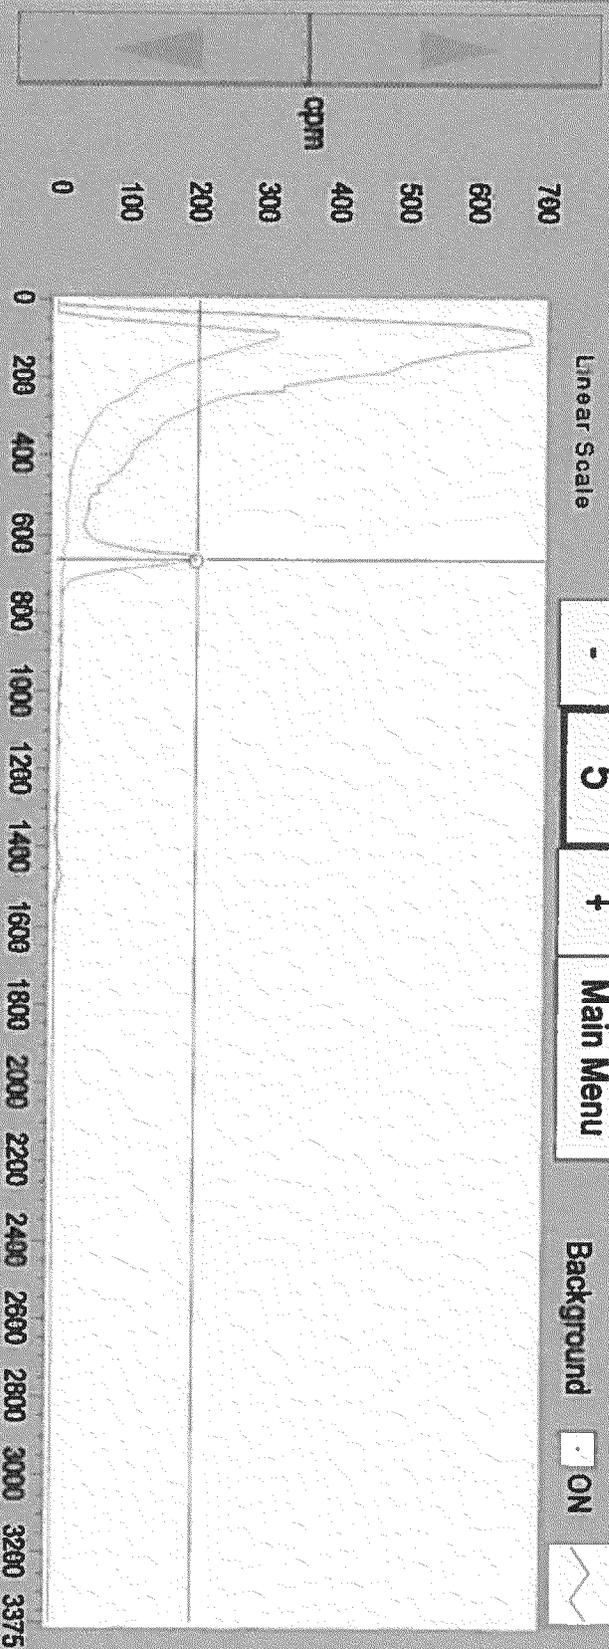
B364 Drain Pipe Spectrum Analysis

A concrete fill iron drain pipe is located under the building just below the ventilator duct area. The pipe also exhibited considerable Cs137 contamination which was confirmed by the spectrum data. A spectrum peak at around 662 kev indicates the presence of Cs137. This pipe should be removed for radiation waste disposal.

HPNS Building 364 Concreted Drain Pipe (blue) vs Asphalt Background (green)

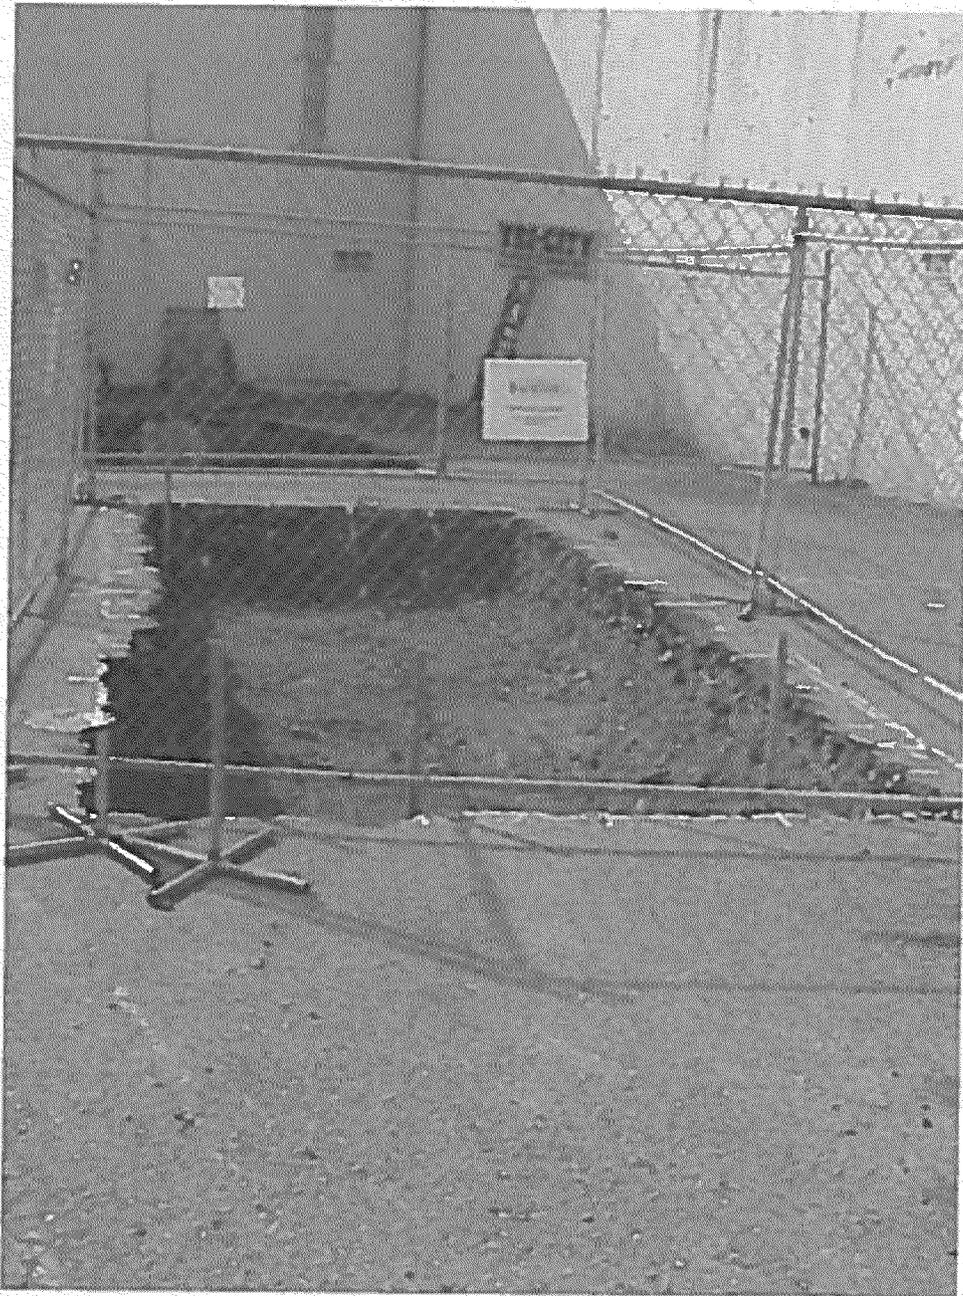
Peanut Spill Removal Pit

My gross gamma survey did not reveal any leveled gamma areas. So, I chose, as closely as I could recall, the region in the spill where the last Cs137 hit had been detected by the GR-130. The spectrum data did not reveal the presence of cesium or any other radionuclide contaminant.

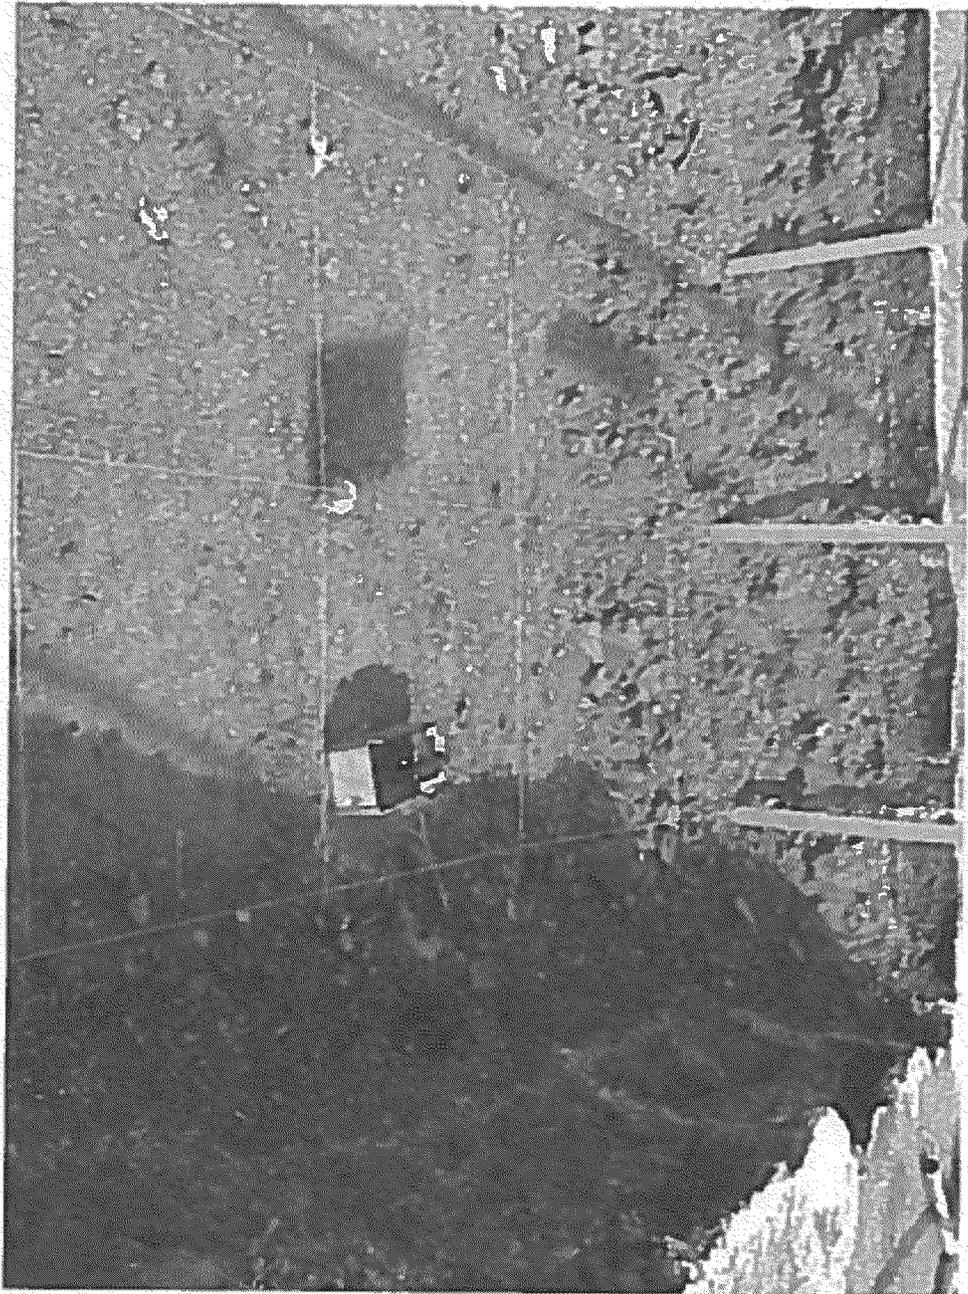
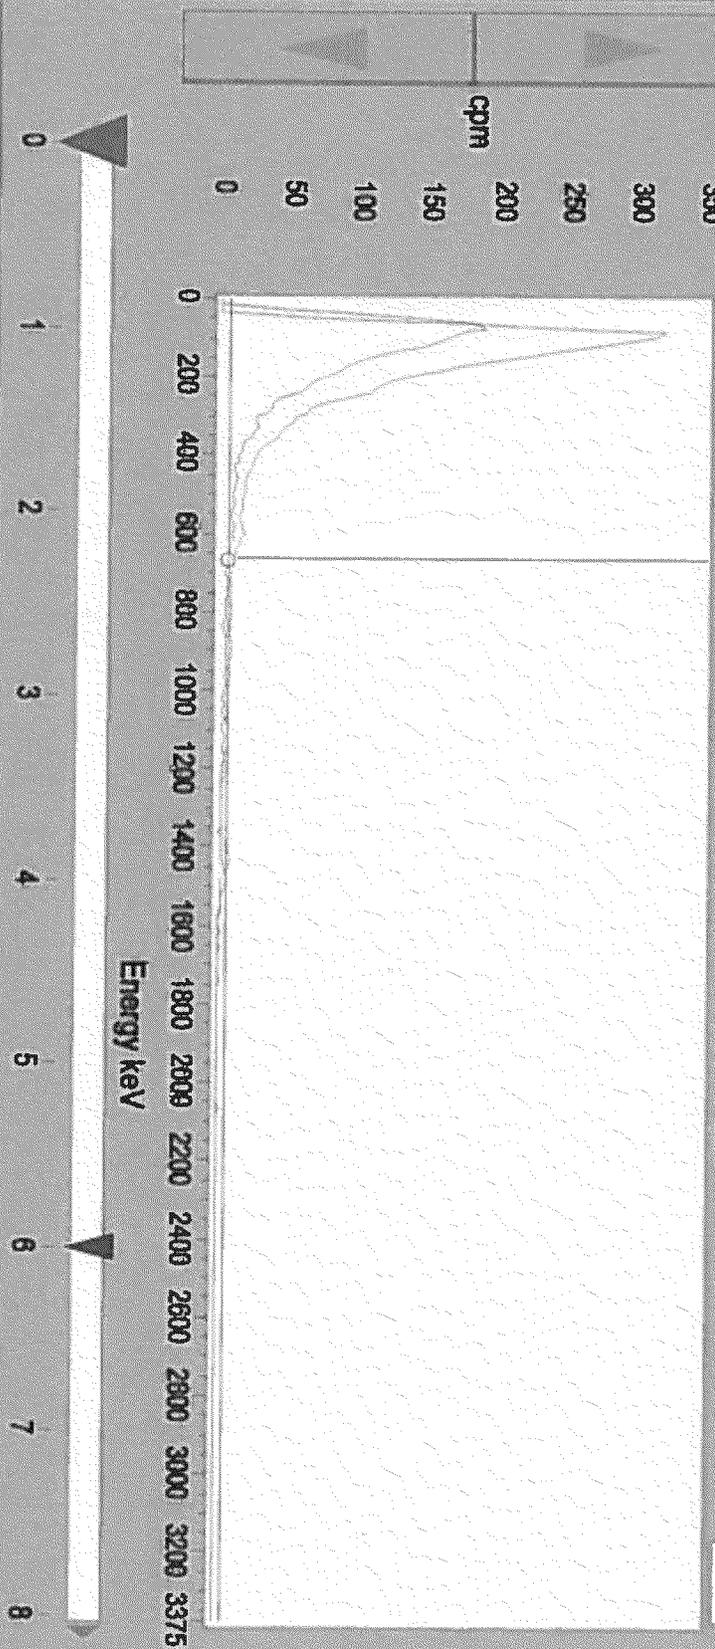
Peanut Spill Removal Pit Spectrum Analysis

HPNS B364 Peanut Spill Removal Pit (blue) vs Asphalt Background (green)

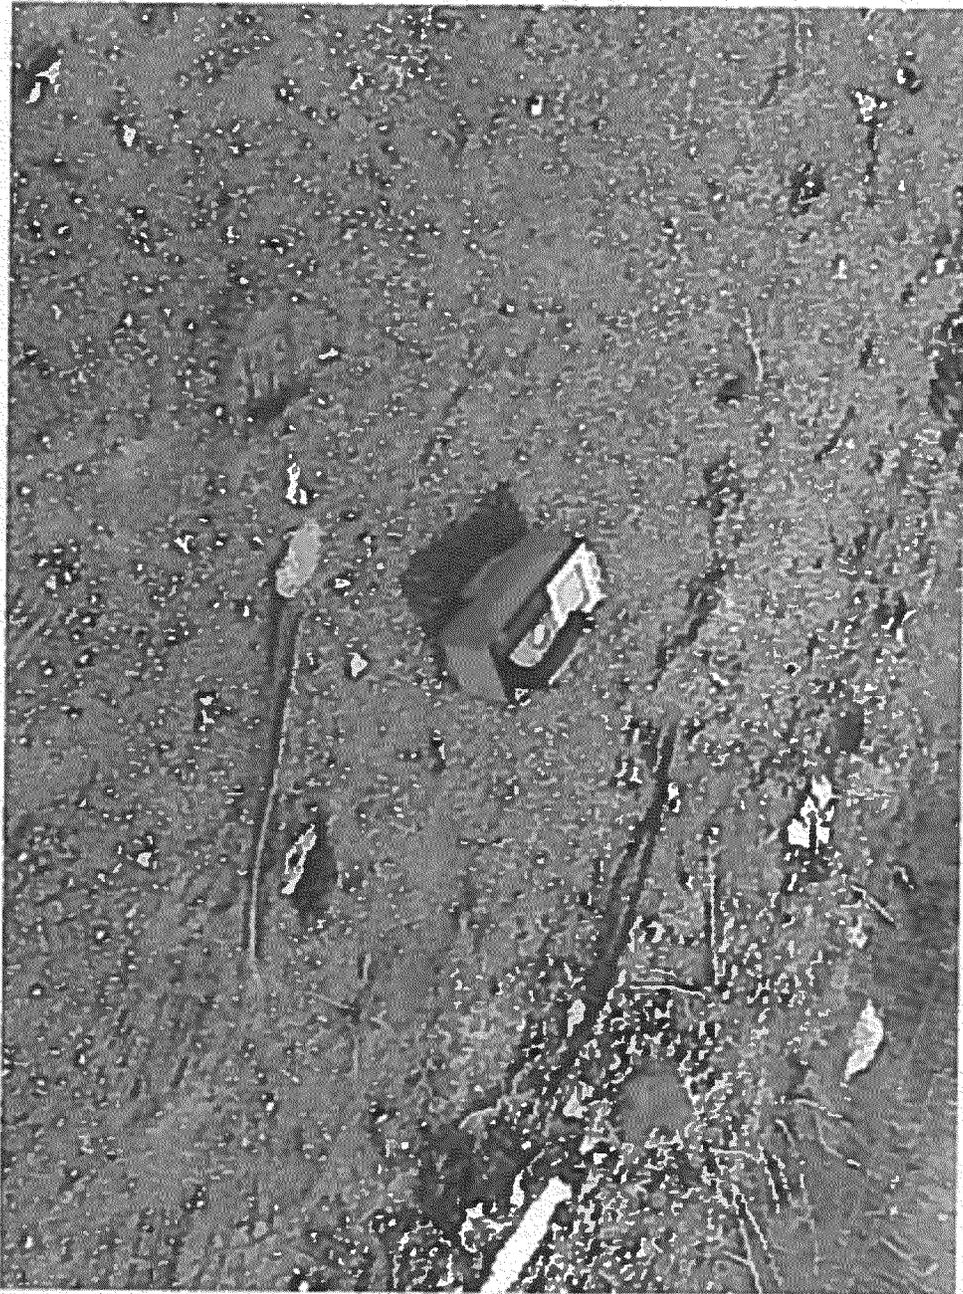
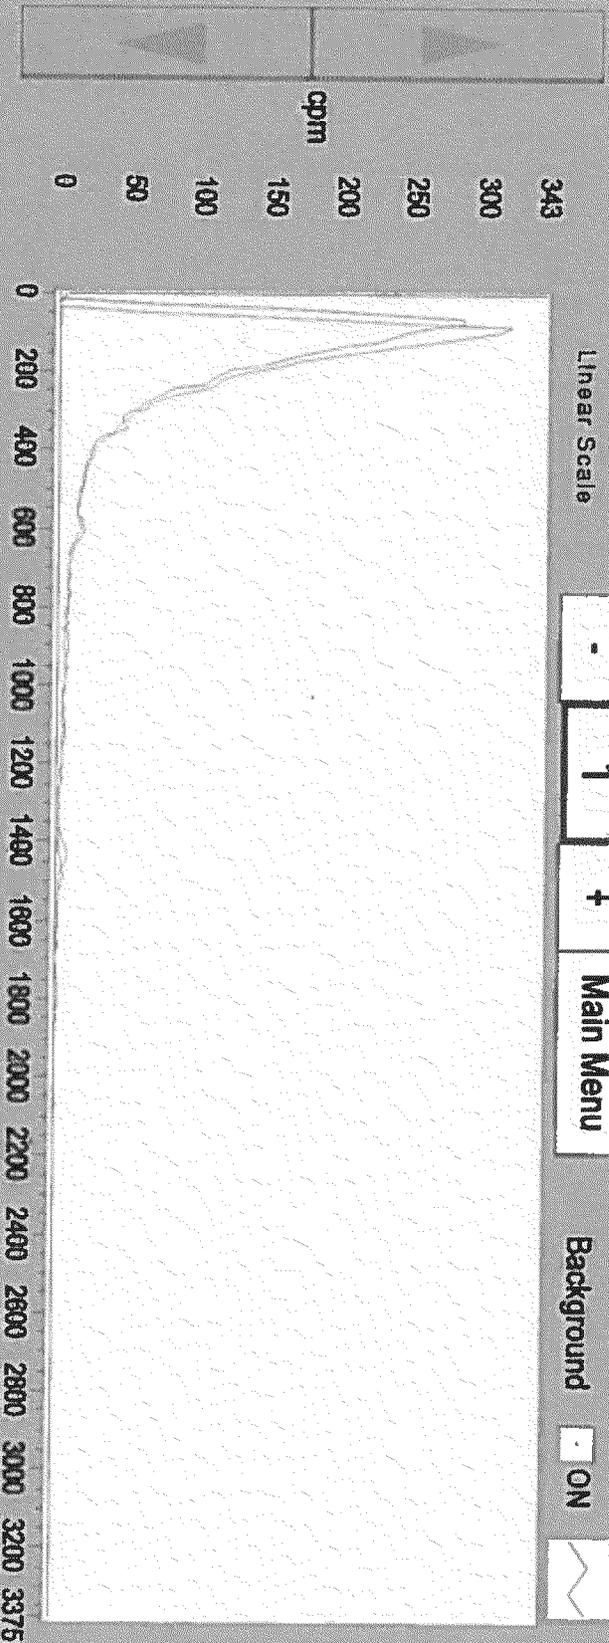
I analyzed an area in Parcel E impacted by black beauty sandblast grit to determine whether or not this material meets the requirements for removal as a radium-226 waste material. The spectrum on very close scrutiny does reveal a slightly elevated peak at 352 kev, a region associated with lead-214 (Pb214) which is a radium decay daughter. The Navy has agreed to remove and dispose of the sandblast grit even though the radium concentration in the grit may not require it.

HPNS Black Beauty Sandblast Grit (blue) vs Asphalt Background (green)
